ARMY RESEARCH LABORATORY

Battle Damage Assessment Telemeter (BDAT) System Impact Test

ARL-MR-398

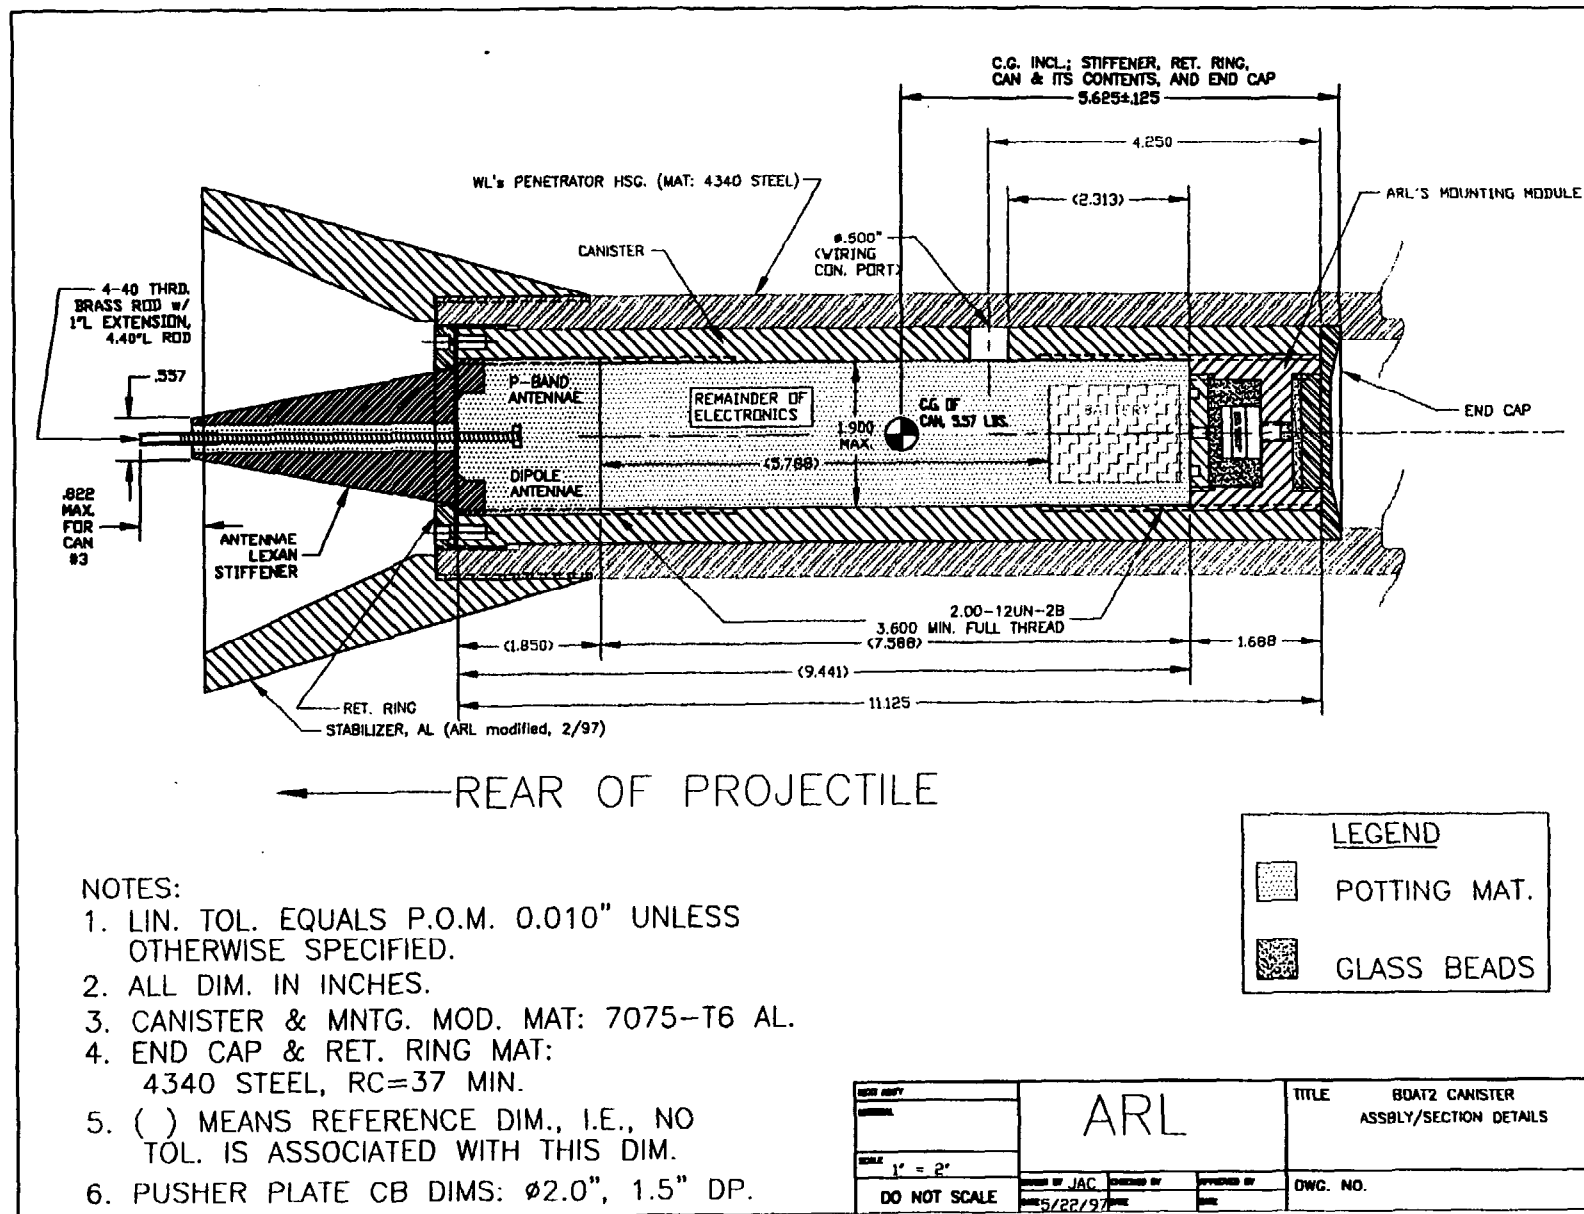
Figure 1. Mechanical Drawing of the Telemetry Canister Inserted in the Projectile.

serve as a baseline, and the sensed unit would provide shock information during impact. Figures 1 and 2 show the telemetry canister and how it interfaces with the projectile. (Total canister/projectile mass at launch was approximately 50 lb_m.)

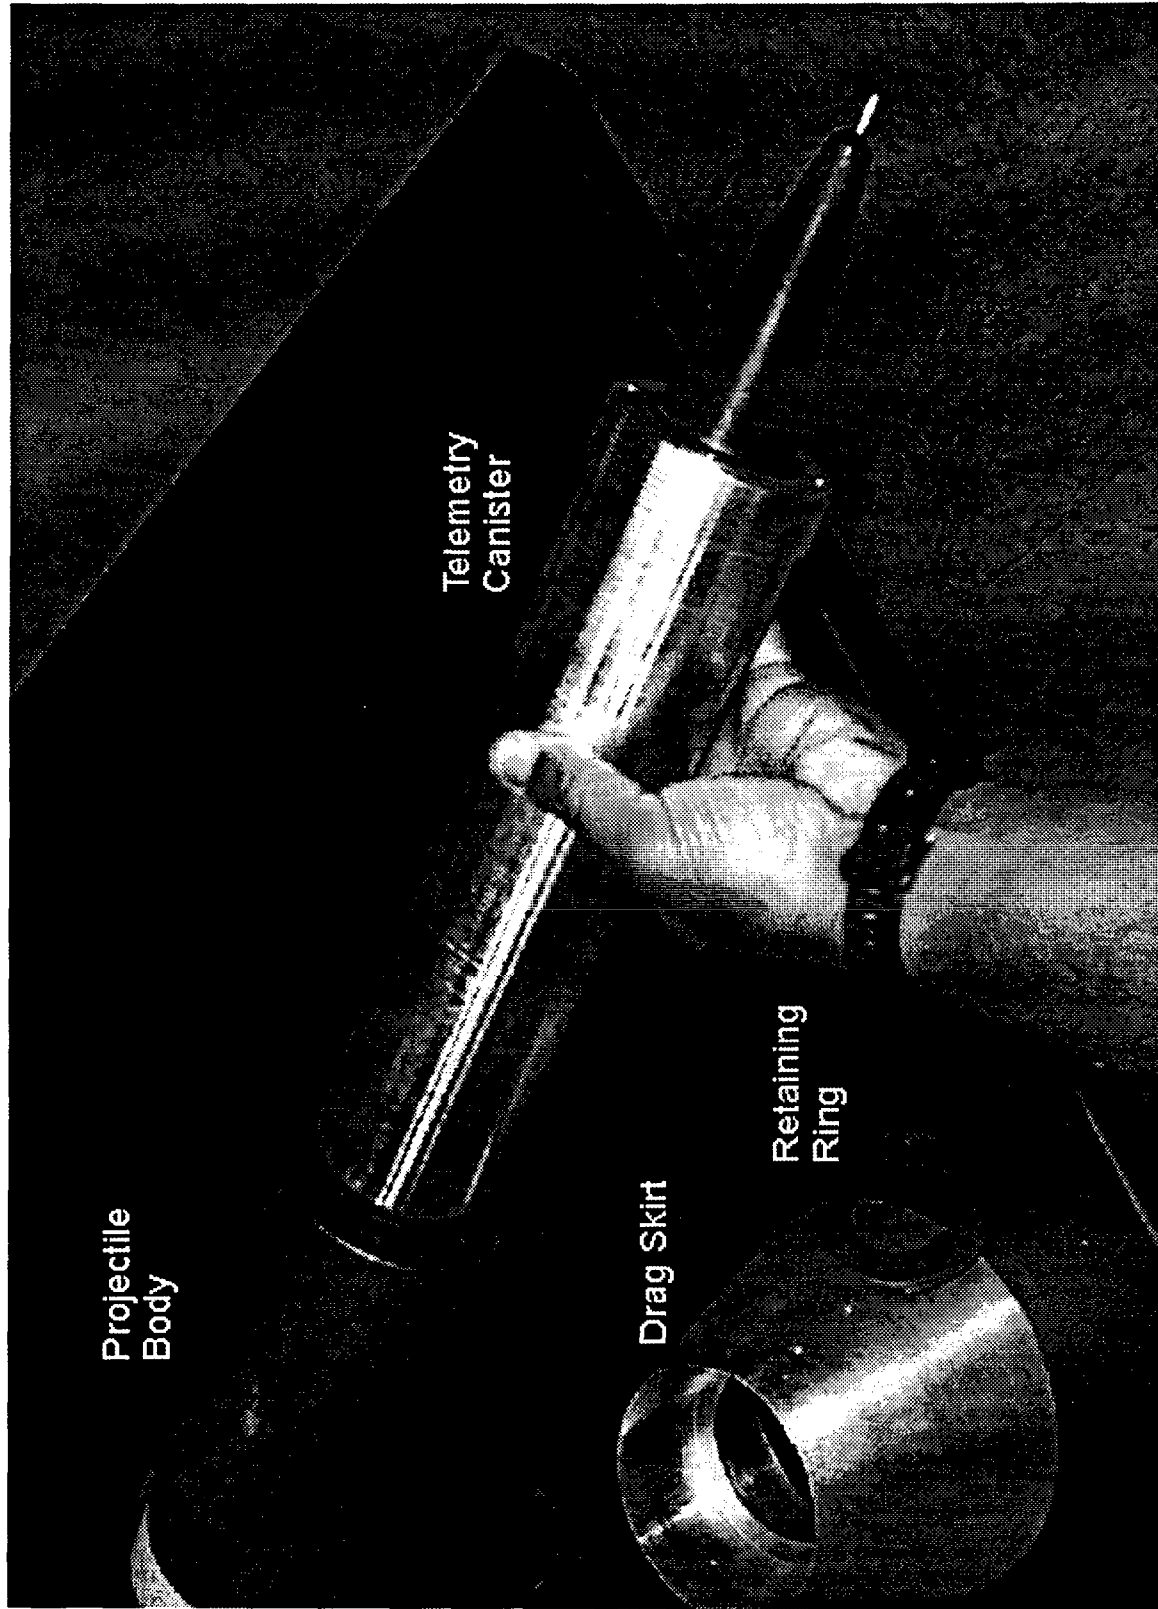
Figure 2. Insertion of Telemetry Canister Into Projectile.

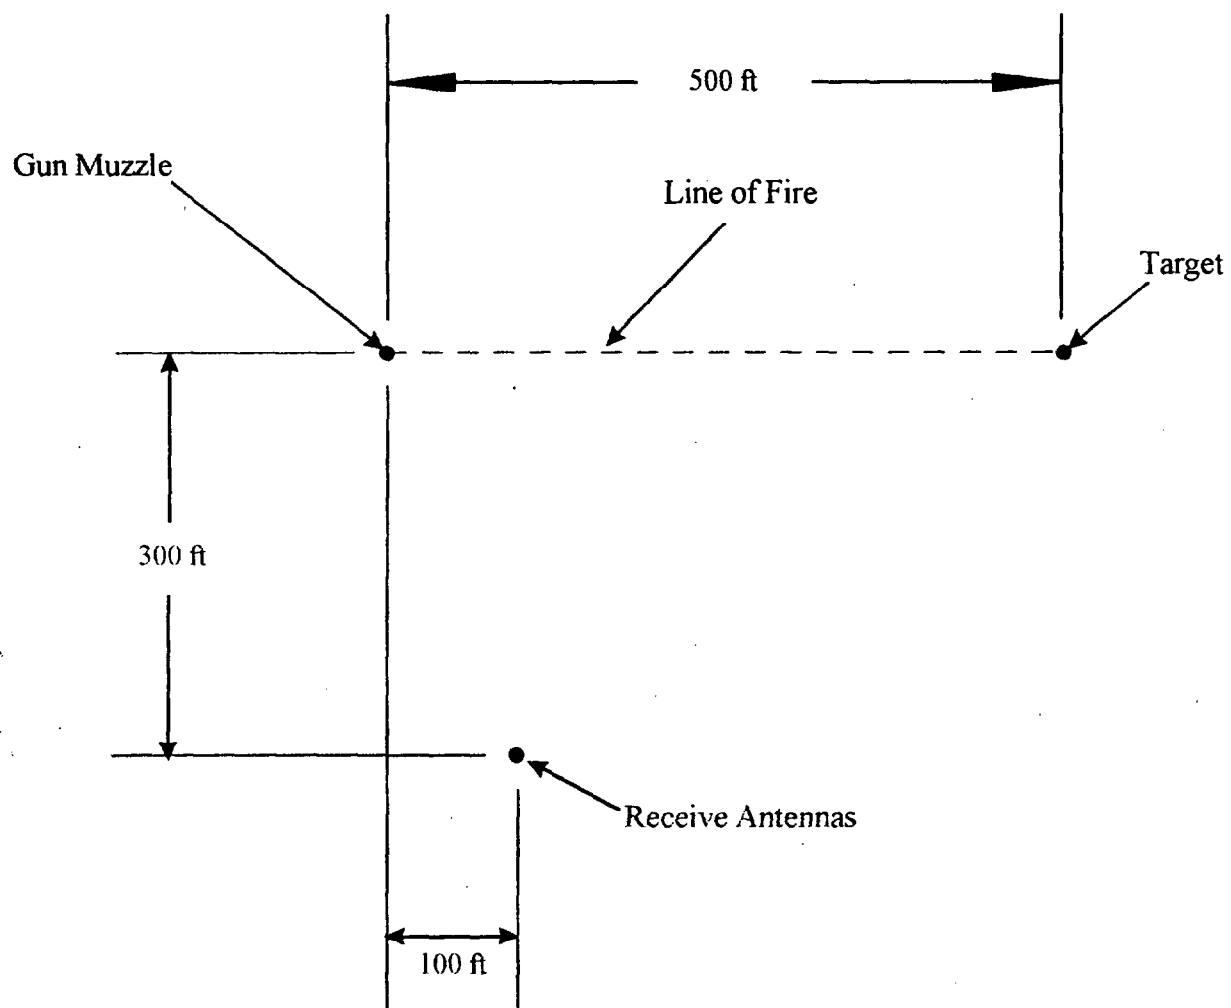
Figure 3. Approximate Positions of the Gun, Target, and Antennas.

The gun, target, and telemetry receiving antennas were positioned approximately as shown in Figure 3. A telemetry canister was turned on, fitted into a penetrator and placed at several points along the line of fire to check the RF link. The amount of activity in the band and the relatively low RF power radiating from the canister made it difficult but not impossible to tune to the test unit. An adequate link was achieved through the entire line of fire.

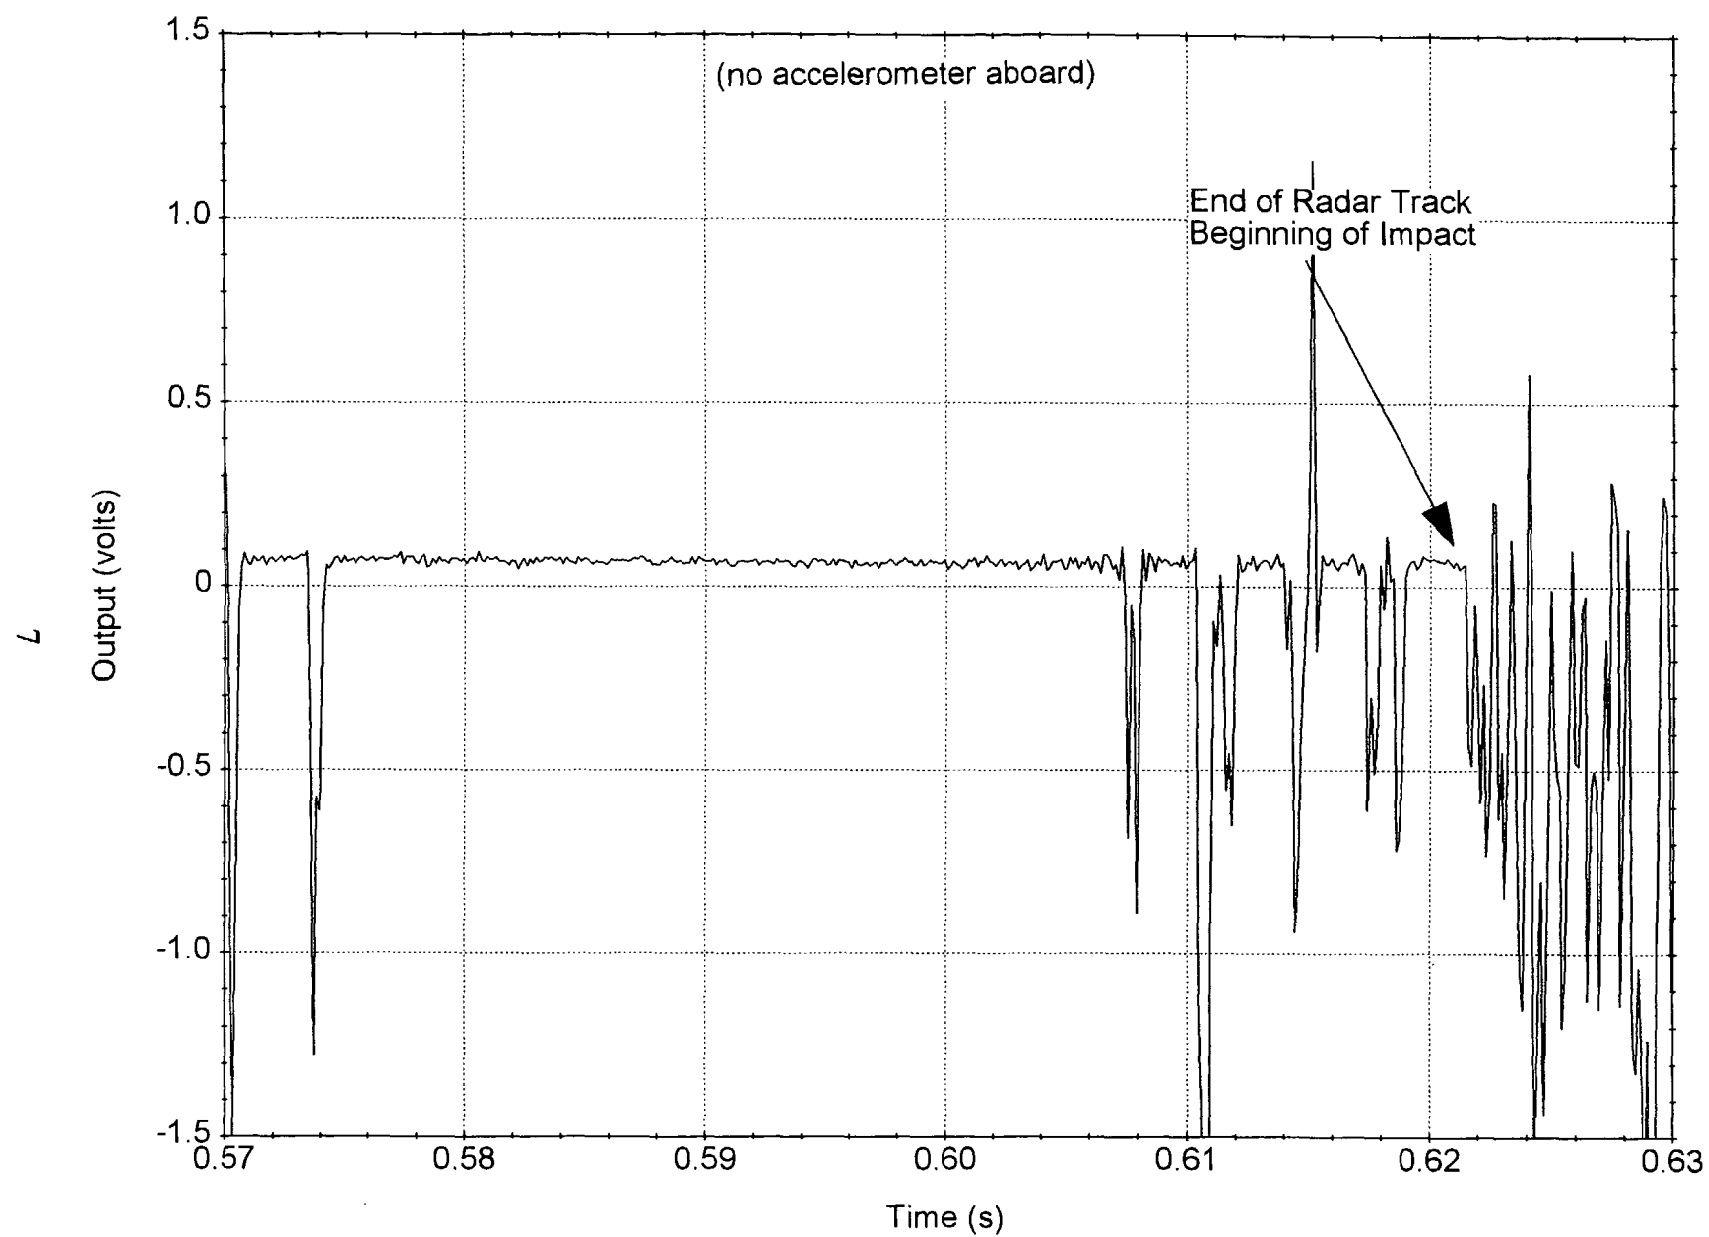
Figure 4. Canister No. 1 Reduced Subcarrier Data.

Data were acquired and analyzed for canisters no. 1 and no. 3 only. The received subcarrier oscillator data were processed to obtain the plots shown in Figures 4 and 5. Since data were acquired in-flight, it was inferred that the antenna tips broke during impact with the concrete target. The radar data were used to establish the time base, and it was assumed that the radar lost track at target impact. High-frequency pulses appear in the plots pre- and post-impact, but they are believed to be noise. Canister no. 3's lower frequency pulse at impact has characteristics different from the surrounding noise pulses and could contain the partial leading edge of the accelerometer pulse. If some accelerometer data were transmitted prior to antenna failure, as this may suggest, then evidence exists that the telemetry system was able to transmit data during the high-shock event.

The data acquired from this test were less than ideal. The amount of noise in the data is a result of the weak RF link between the telemetry and receiving antennas and the broad-band noise near the transmitter frequency. The transmitting antenna was designed and shock-table tested to withstand 21,000 g's of shock 10° off axis. Shock-table tests performed after the gun-launch test showed that the antenna could withstand over 28,000 g's of shock 10° off axis. Perhaps the actual shock levels exceeded the tested limits [in peak and/or duration] and caused the failure. The data presented here do not offer a definitive answer to the robustness of the telemetry components under high shock. The data are just too noisy, but those extracted near the time of impact do suggest that the telemetry system could transmit data during a high-shock event if the antenna could survive. Since the subcarrier oscillator was detected on all the canisters after impact, we now know that the telemetry components other than the antenna will survive multiple shocks caused by launch and impact.

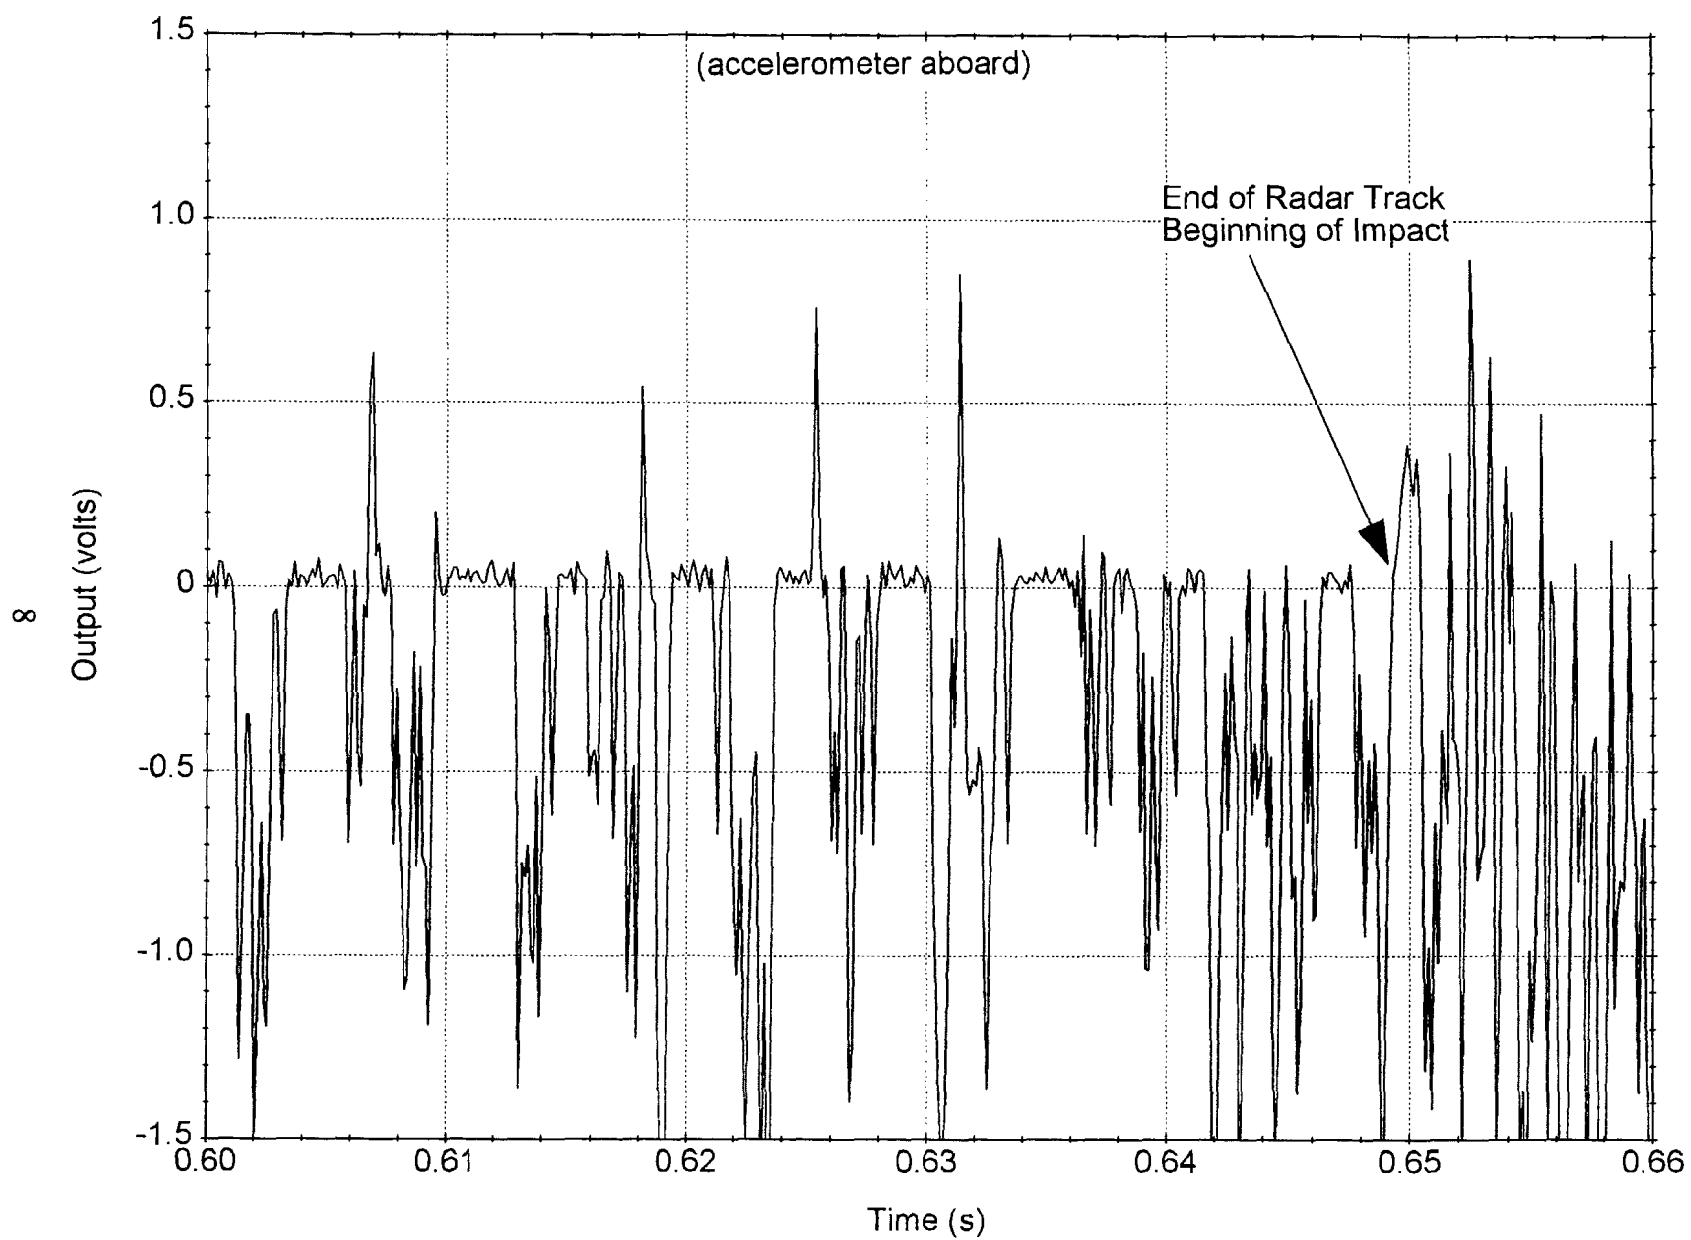
Figure 5. Canister No. 3 Reduced Subcarrier Data.
